# WIRELESS ALARM SYSTEMS

## OUTDOOR PROTECTION

## OUTDOOR MOTIONVIEWER **OMV**

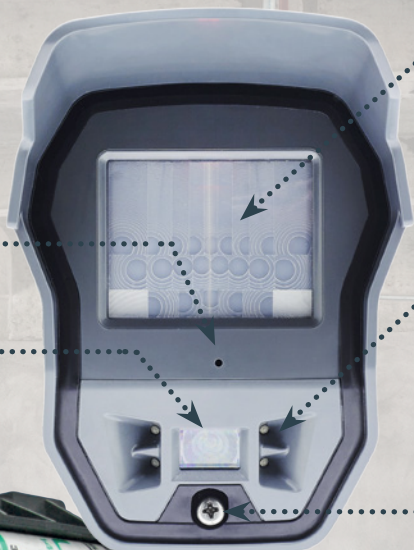
Externally accessible programming button

New QVGA day/night video camera

Inputs (3)/output (1) terminals to integrate (and video-verify) 3rd party devices such as panic buttons, doorbells, pressure mats, beam sensors, gate contacts, etc.

4 LS14500 Lithium AA batteries, longer between changes

4 Fresnel lens options plus masking kit for customizable detection, application flexibility, and reducing potential false alarms

4 infrared illuminators for brighter nighttime video, with illumination range at 30' (from device to ground)

One-screw removal of the body for easy battery change; simple install and field maintenance

Use	Outdoor
Video	Colour
Operating temperature	-25° / +70°C (-20° / +140°F)
Installation	Mounting Bracket (Réf. MB110)
Tamper	✔ With an accelerometer captor
Angle detection	90° by default
Lenses	3 spare in the box: Vertical curtain, horizontal curtain (pet immune), long range
Masking kit	✔
Input/Output	✔
Battery life	4 years
Protection rating	IP65/IK06
Power supply	4 LS14500 lithium batteries
